Site monitoring report

Site Name: Blackley Quarry, Gt Leighs, Chelmsford, Essex, CM3 1QP

Date: 31 August 2023

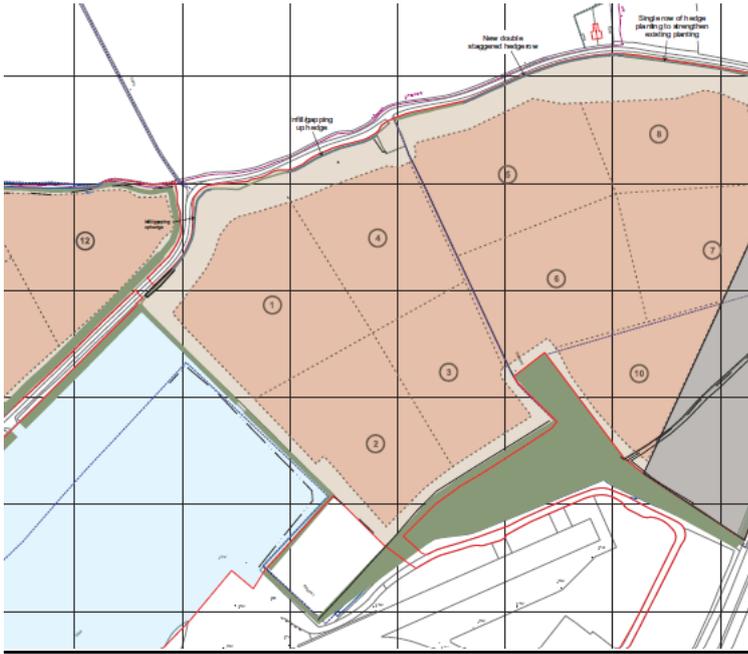
A38 Extraction area

Extraction continuing in phase 5, moving into 6. Dry screener located on surface of phase 6. This plant should be operated at a low level within the void, to minimise noise impact.

New plant operational, however, at this stage does not have planning permission, application still outstanding awaiting additional information on landscape and noise. New noise consultant appointed.

Stand-off to Blackley Cottages from the excavation face was being maintained.

Operate dry screener at lower level with site A38.
