Site monitoring report

Site Name: Highwood Quarry, Stortford Road, Little Canfield

Date: 31 August 2023

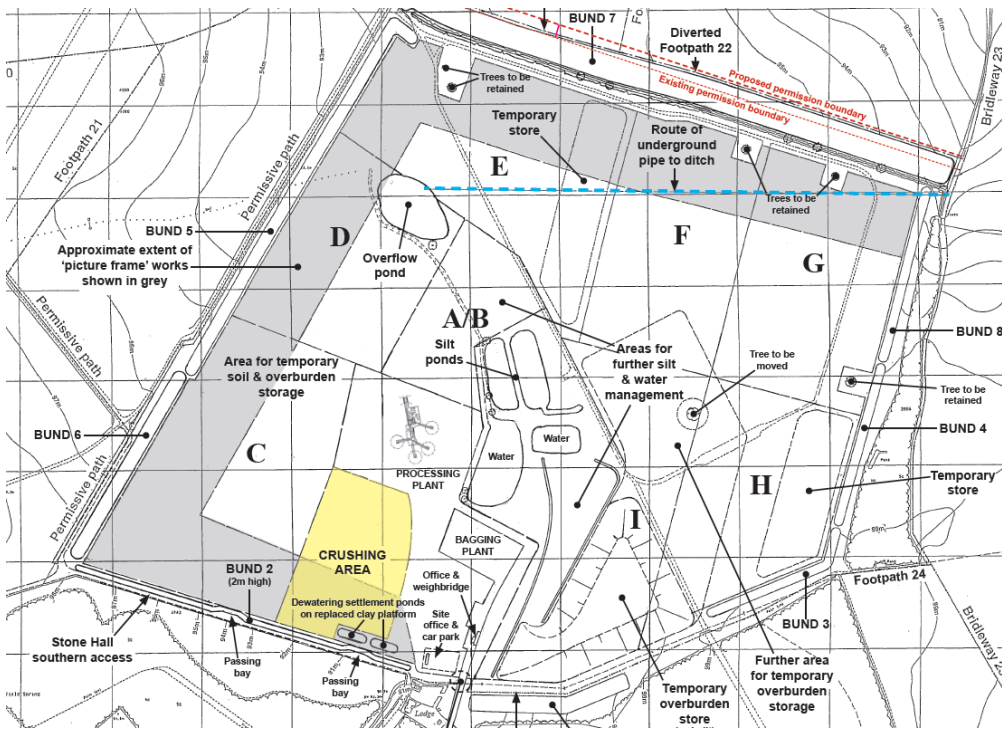
Phase E, restored to restoration levels and in part topsoiled. This area needs to be cut to reduce weed infestation and stone picked. To be brought into restoration when works in track on boundary D/E until an area larger enough to be put into aftercare is created.

It is understood once the track area has been worked and restored the bunding around veteran trees will be removed.
