Site monitoring report

Site Name: Highwood Quarry, Stortford Road, Little Canfield

Date: 8 Dec 2023

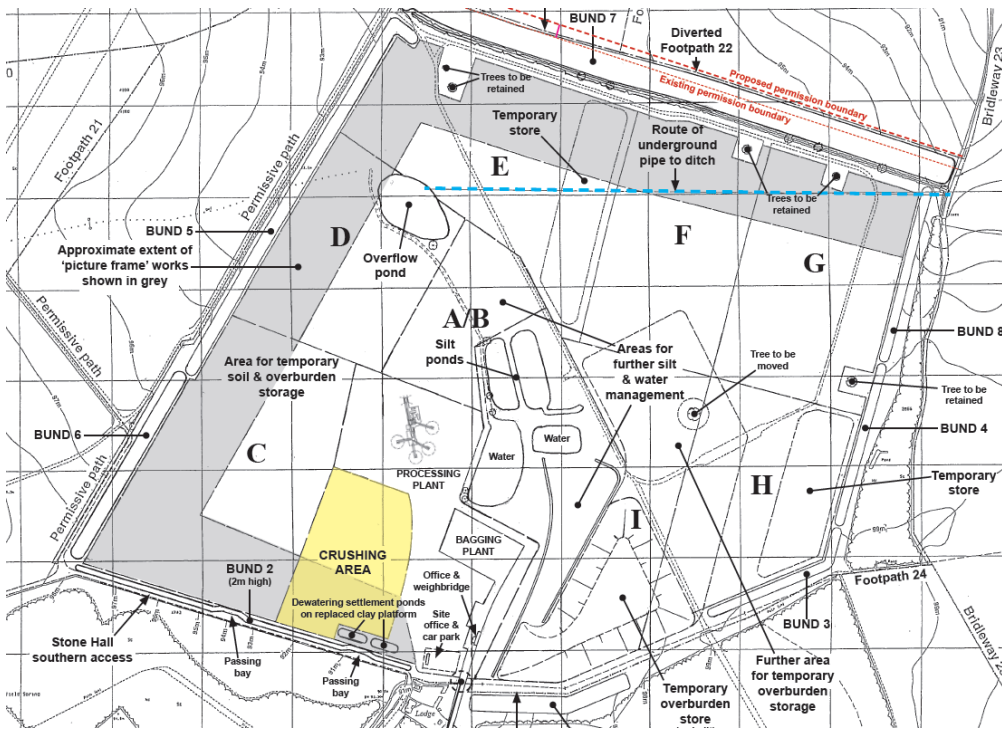
It is understood once the track area has been restored the bunding around veteran trees will be removed.
