# Site monitoring report

**Site Name:** Highwood Quarry, Stortford Road, Little Canfield

**Visit no:** 4 of 4

**Date:** 27 March 2024

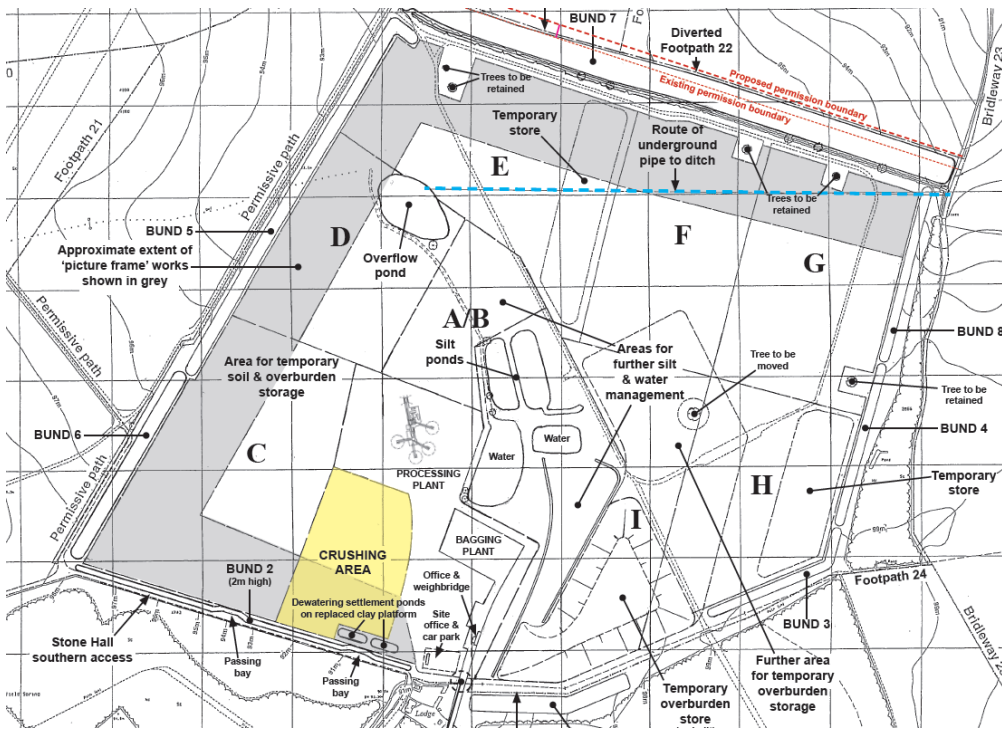
It is understood once the track area has been restored the bunding around veteran trees will be removed.

It should be noted if Stone Hall is reoccupied, it will be necessary to reinstate 3m high bunds around phase C or ensure screening of plant and extraction areas from Stone Hall.
