Site monitoring report

Site Name: Bulls Lodge Quarry, Generals Lane, Boreham, Essex, CM3 3HR

Operator: Hanson Aggregates

Date: 25 March 2024

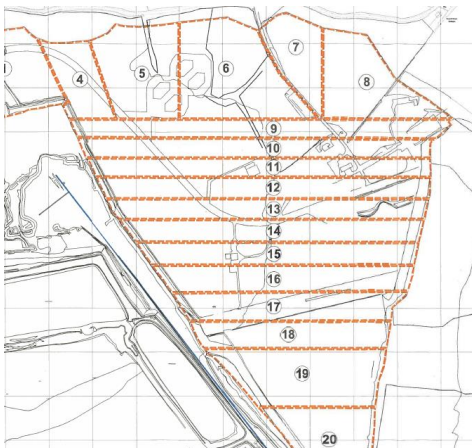
Extraction area Airfield

Northern edge of phases 5, 6, 7 and 8 to restoration levels. Phase 4 still requires some material. Areas up to restoration levels, topsoil to be placed when soils are dry in summer 2024.

Extraction in east end of 11, 12 and 13 complete.

Overburden not fully stripped in east end of 14,15 and 16.

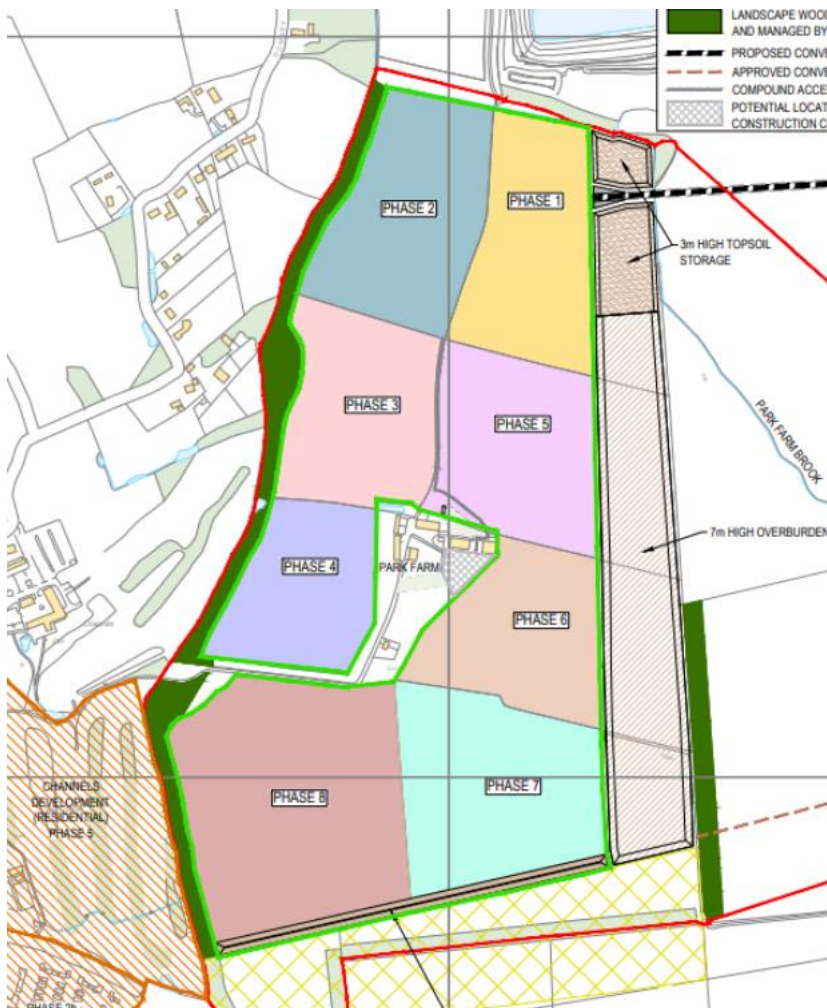
Park Farm Extraction Area

North boundary of Phase 1 and 2 and east side of road into Park Farm - gapping up planting undertaken.

Phase 1 and 2 archaeological investigation completed. Archaeological investigation ongoing in area for overburden storage.

Anticipate topsoil strip in phase 1 and 2 Q2 2025. There is a power cable to move, likely Q1 2025.

Archaeology planned for phases 3/4/5/6 2025
